MISCELLANEOUS PAPER GL-82-17

EVALUATION OF SOD SAVER BLOCKS AND M. C. GILL PANELS FOR TACTICAL BRIDGE ACCESS/EGRESS APPLICATIONS

Geotechnical Laboratory

October 1982

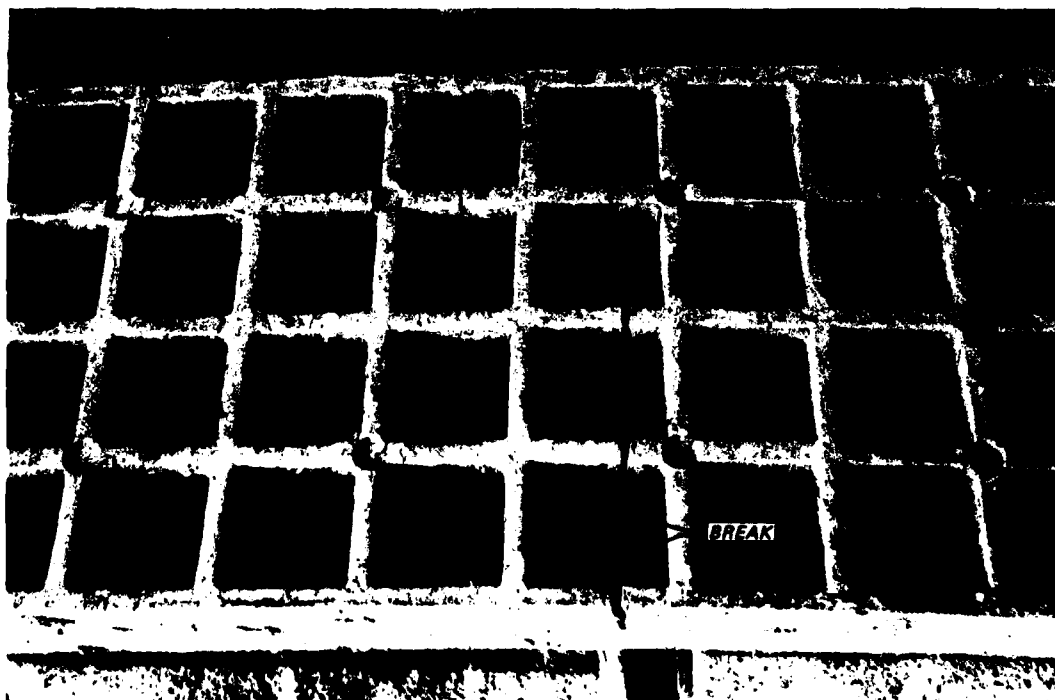
Photo 22. Close-up of break in bottom of Sod Saver Block at failure after 39 passes with 5-ton truck

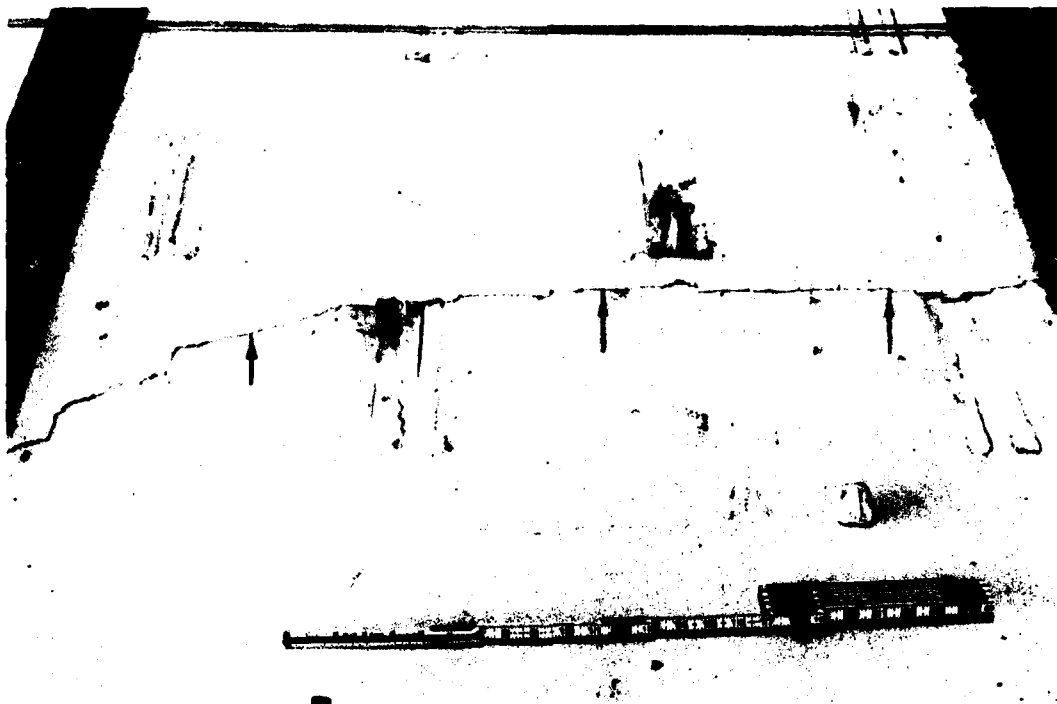
- i. 168 passes. The top skin break in panel 1 extended completely across the panel (Photo 33).
- j. 194 passes. The metal edge channel on panel 1 was completely broken, and the top skin in the broken area mentioned after 168 passes was disbanded completely across the panel.

Photo 33. Break in panel 1 after 168 passes with M48A1 tank

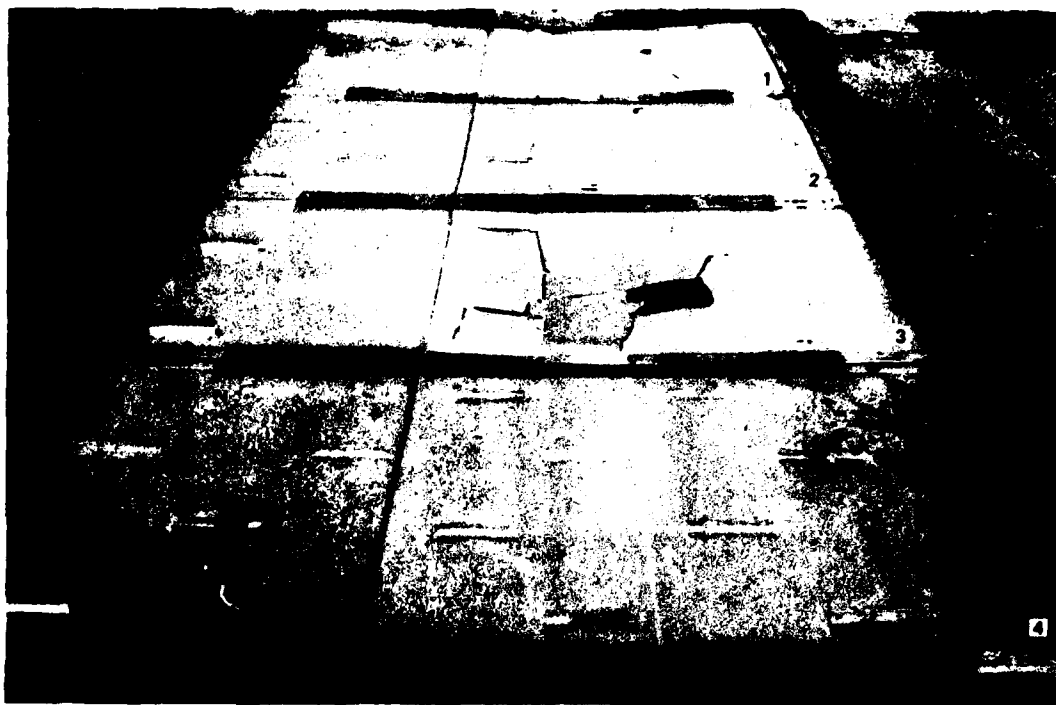
Photo 37. General view of item 2 at failure after 1920 passes (200 tank and 1720 truck passes)

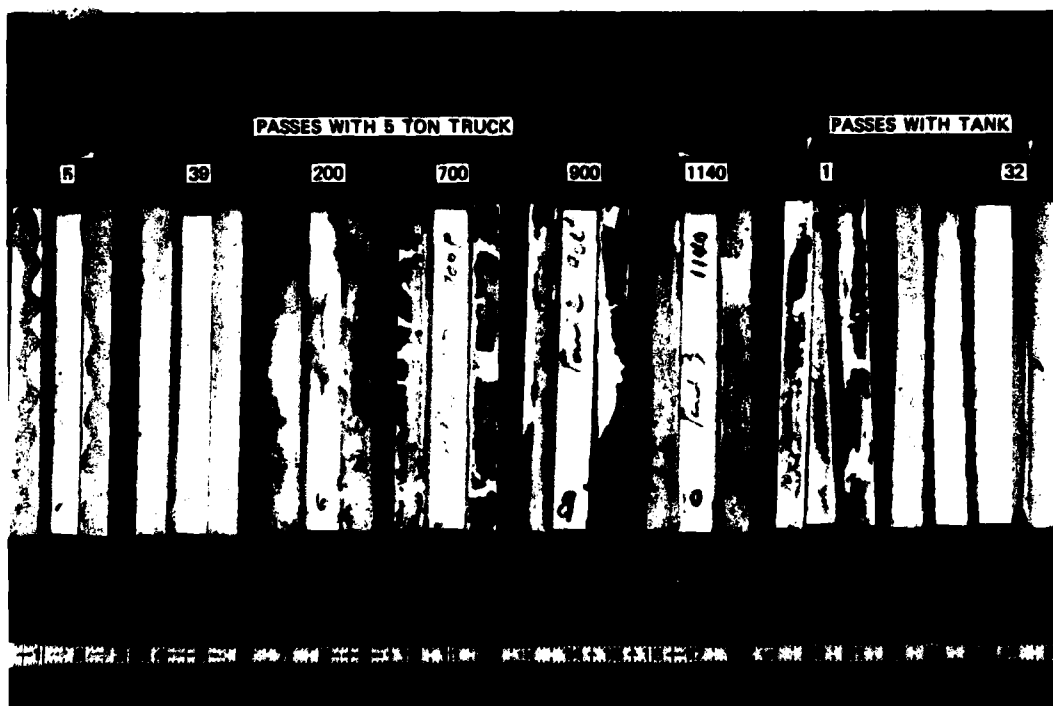
- a. Cleat 1 failed at 5 passes as a result of poor adhesive application between cleat and panel skin.
- b. Cleat 3 failed at 39 passes, due to adhesion failure (glue-metal interface).

- c. Cleat 6 failed at 200 passes due to skin failure in the area of the bond.
- d. Cleats 7, 8, and 10 failed at 700, 900, and 1140 passes, respectively, due to a combination of cohesion and adhesion failures.
- e. Cleat 14 failed at 1 pass with the M48A1 tank. This failure was caused by metal crushing under load.
- f. Cleat 26 failed at 32 passes with the M48A1 tank due to complete metal failure by breaking.

Photo 39. Cleats that failed and were torn from M. C. Gill panels; failures indicated at various phases

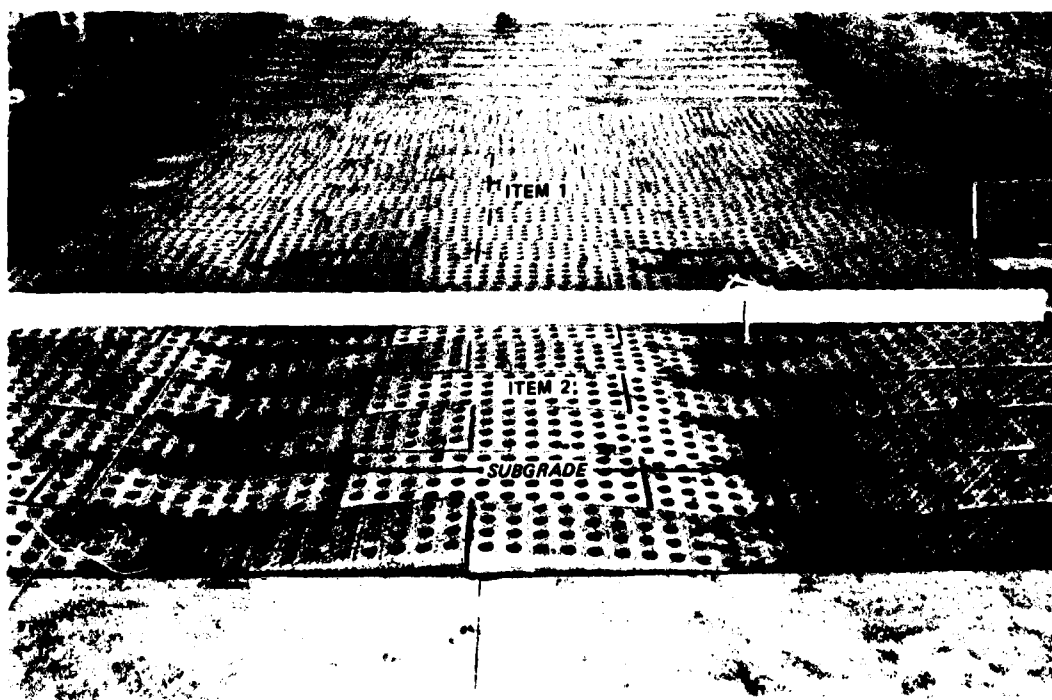
Photo 44. General view of test section after 50 passes with 5-ton truck; note permanent deformation and subgrade pumping in item 2, test II

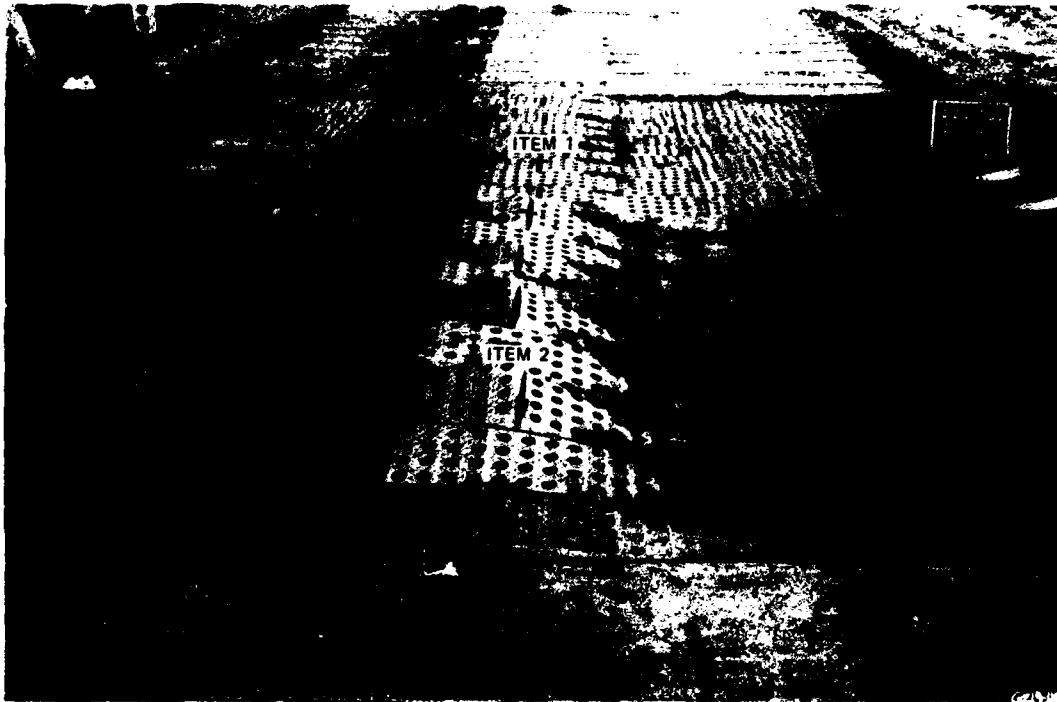
28. The 5-ton truck was loaded with 20,000 lb (40,000 lb total weight). Item 2 failed after 33 additional passes with this loading. The blocks in item 2 had become severely deformed, and several rings had pulled through the block ends. This condition caused the undercarriage of the truck to drag. A general view of the test section with item 2 failed after 133 passes with the 5-ton truck and 25 passes with the M48A1 tank as shown in Photo 45.

Photo 45. General view of test section showing item 2 failed after 158 passes (25 tank and 133 truck passes), test II

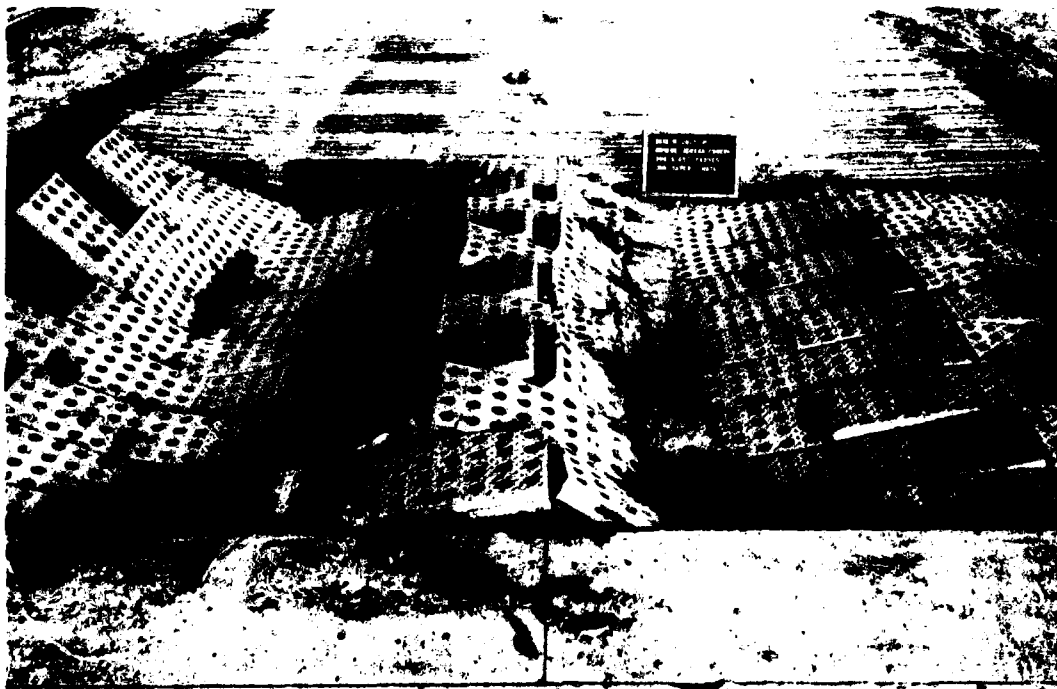
29. Traffic continued on item 1 with the 5-ton truck for a total of 300 truck and 25 tank passes. Item 1 was considered failed due to broken Sod Saver Blocks which caused deep ruts and also rings which pulled out of the block ends at the centerline, allowing the truck undercarriage to drag. The maximum rut depth was recorded at 15-5/8 in. in the west wheel path. Cross-sectional and profile data are shown in Figures 14-19. The cross-sectional data in item 1 show that the average maximum difference in elevation between 0 passes and 100 passes was 1.7 and 2.0 in. in the west and east wheel paths, respectively. The same data taken after 300 passes at the same locations showed average maximum elevation differences of 6.8 and 7.0 in. in the west and east wheel paths, respectively. The average maximum difference in elevation when measured on the block surface was 11.1 in. (measured from bottom of rut to highest point at center of traffic lane), as shown in Figures 16-17. The permanent deformation profiles show that for each additional 100 passes applied, the average maximum deformation increased 2.02 in. at

2-1/2 ft east of the center line and 2.47 in. at 3-1/2 ft east of the center line. These data also indicate how the subgrade was displaced, as discussed earlier. A general view of this failed item is shown in Photo 46. A close-up of the failed blocks is shown in Photo 47. Broken blocks and rings pulled loose from panel ends are shown in this photograph. A close-up of a typical break in a Sod Saver Block is shown in Photo 48.

Photo 46. Item 1 (with runners) failed after 325 passes (25 tank and 300 truck passes), test II

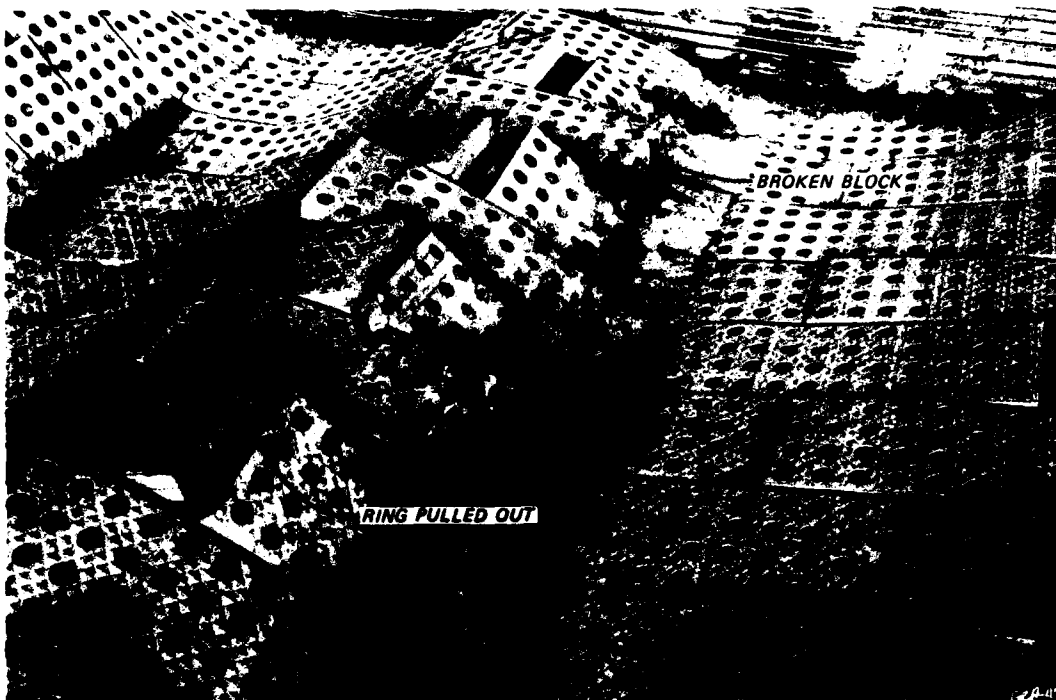
Photo 47. Close-up view of item 1 (with runners) failed after 325 passes (25 tank and 300 truck passes), test II

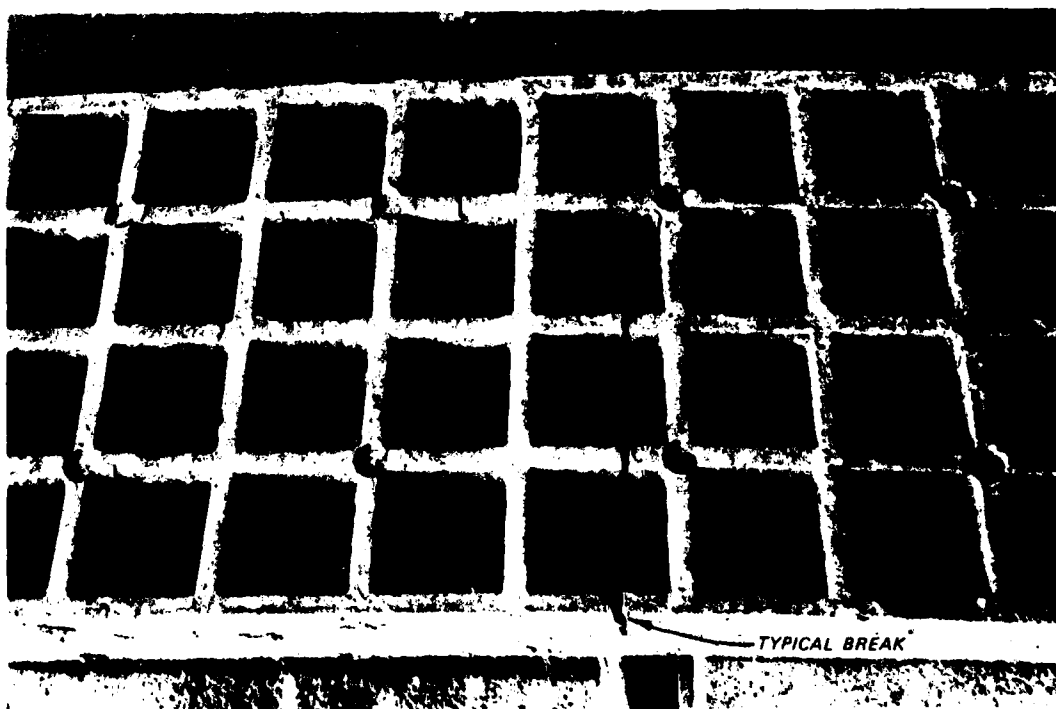
Photo 48. Close-up of a typical break in the bottom of a Sod Saver Block at failure
